**A QUICK REPORT
ON
PAZARCIK AND EKİNÖZÜ EARTHQUAKES
(TÜRKİYE) OF FEBRUARY 6, 2023**

Ömer AYDAN* and Reşat ULUSAY**

15 February 2023

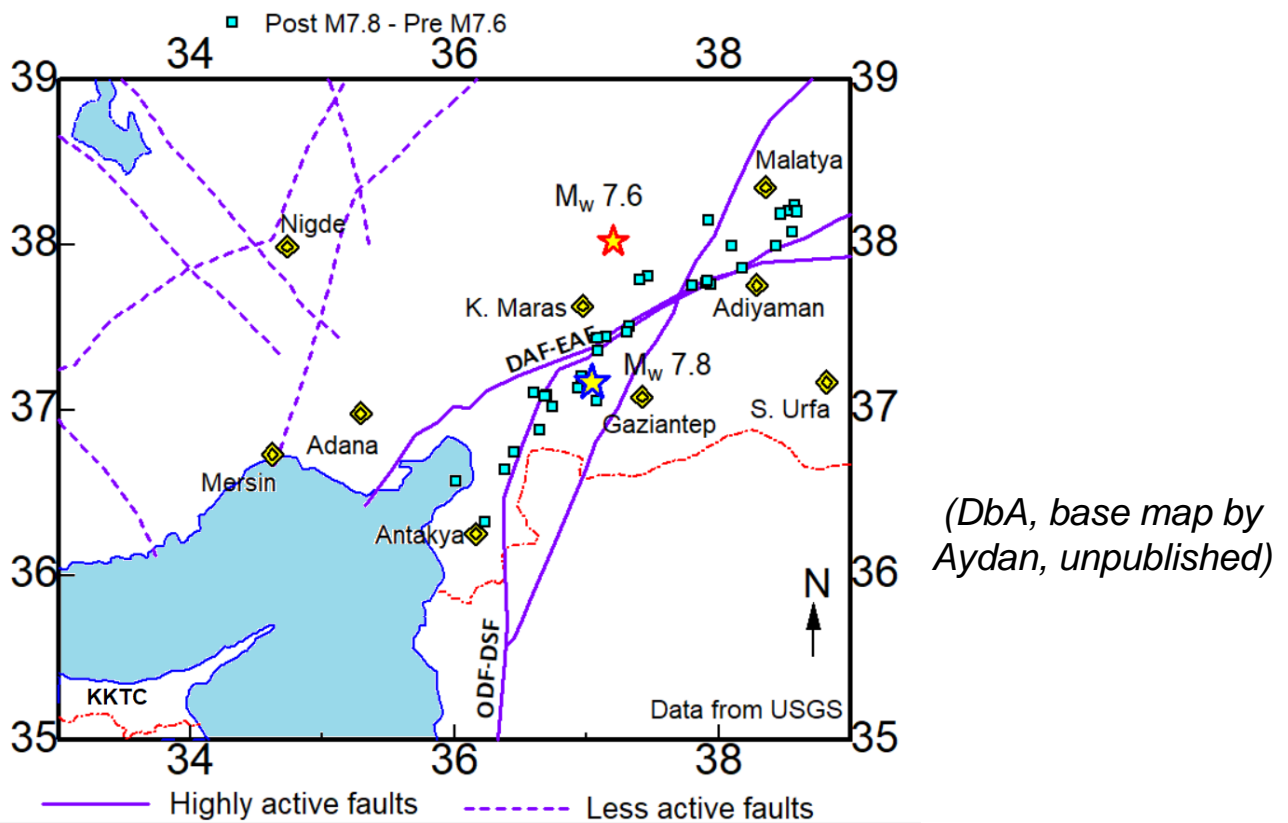
The Pazarcık earthquake involved EAFZ (2 segments) and DSF-Death Sea Fault (1 segment). The total length of the surface rupture could be in the order of 210-230 kms.

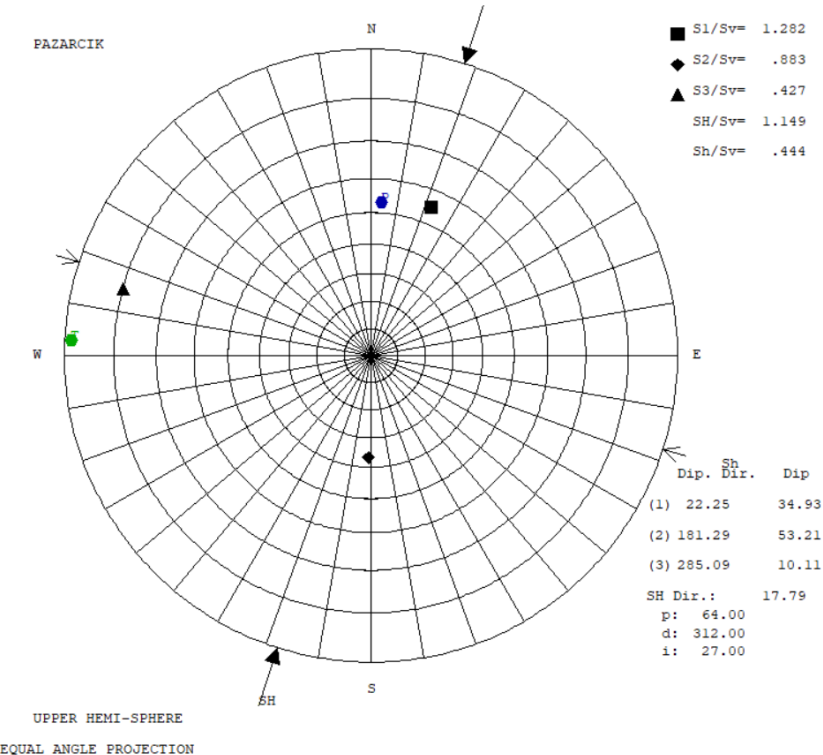
Inferred crustal stresses of the epicentral area for focal plane solution by KOERI using Aydan's Method (Aydan 2000a, 2016, 2020). KOERI focal mechanism involves normal component as observed in-situ (DbA).

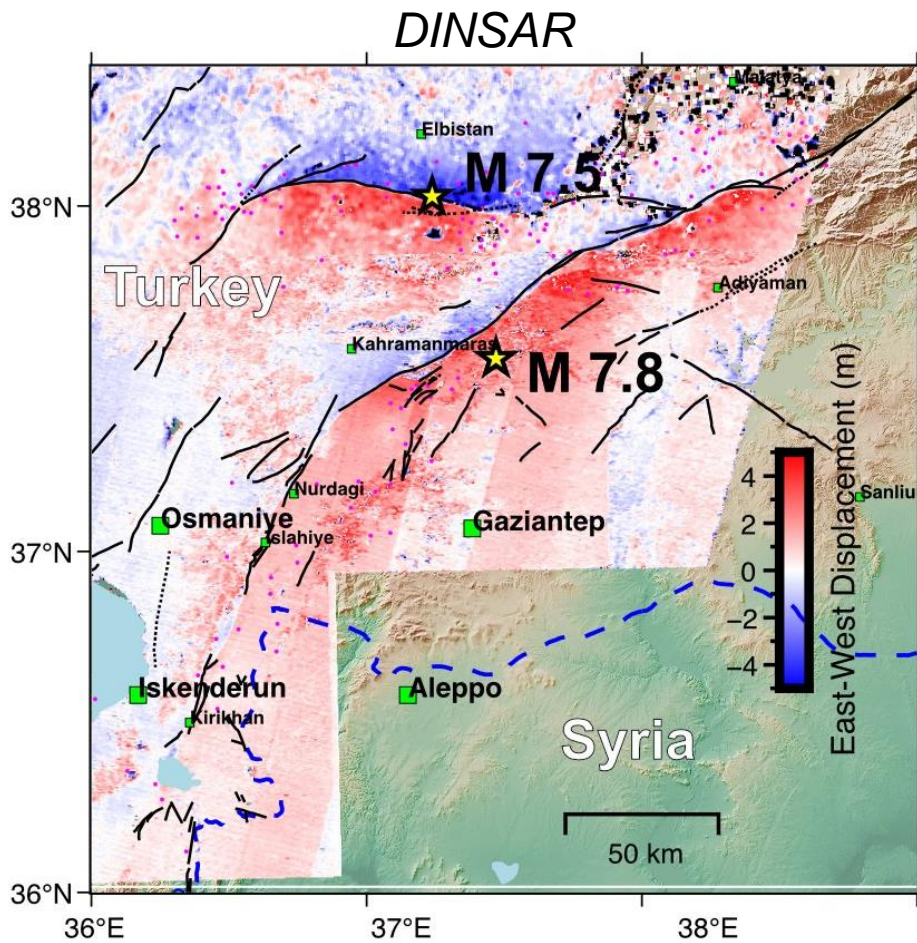
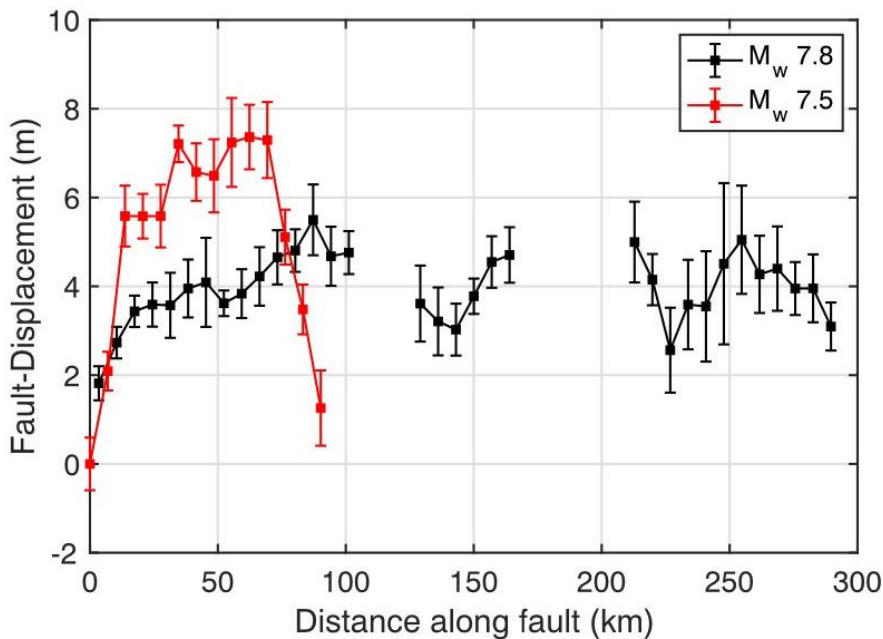
The Pazarcık earthquake caused about 5-6 m sinistral slip and the distribution has a parabolic shape. While the Ekinözü earthquake has the same sense of relative slip, the shape is triangular

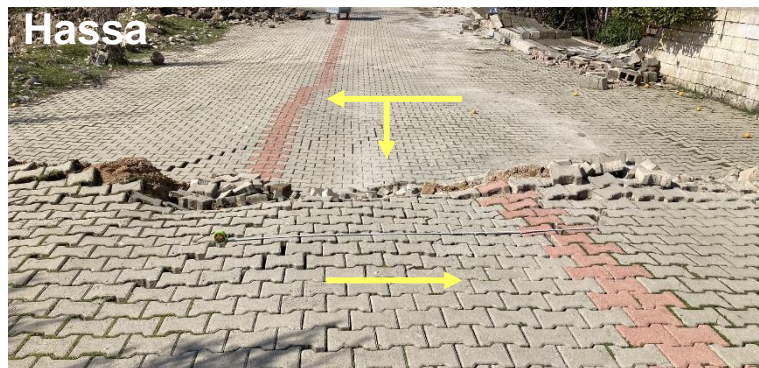
Hassa

Relative slip is generally more than 300 cm in many rupture observations and the southern rupture has also normal component. This may also explain why some part of İskenderun city subsided and immersed by sea-water. Şekeroba – Kırıkhan segment is on Dead Sea fault.

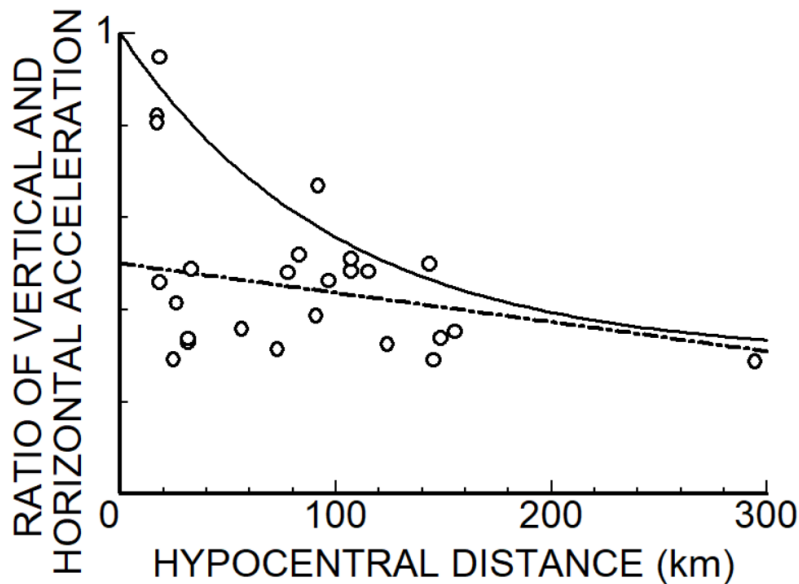
The vertical component of strong motions near the fault rupture is quite high and it decays with distance

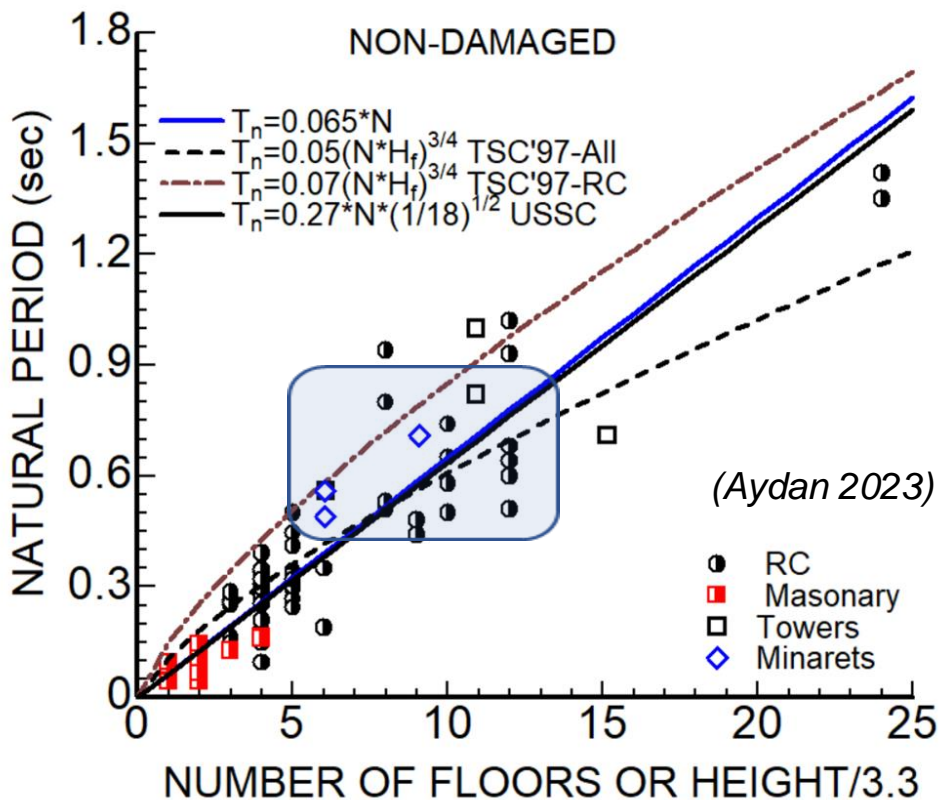
Most of RC buildings has 5 to 14 stories. The estimated natural frequency for the first mode ranges between 0.3 to 0.9 seconds, this might have an influence on their collapses. If the design and construction were properly done according to the Turkish Seismic Code, this scale damage would not occur

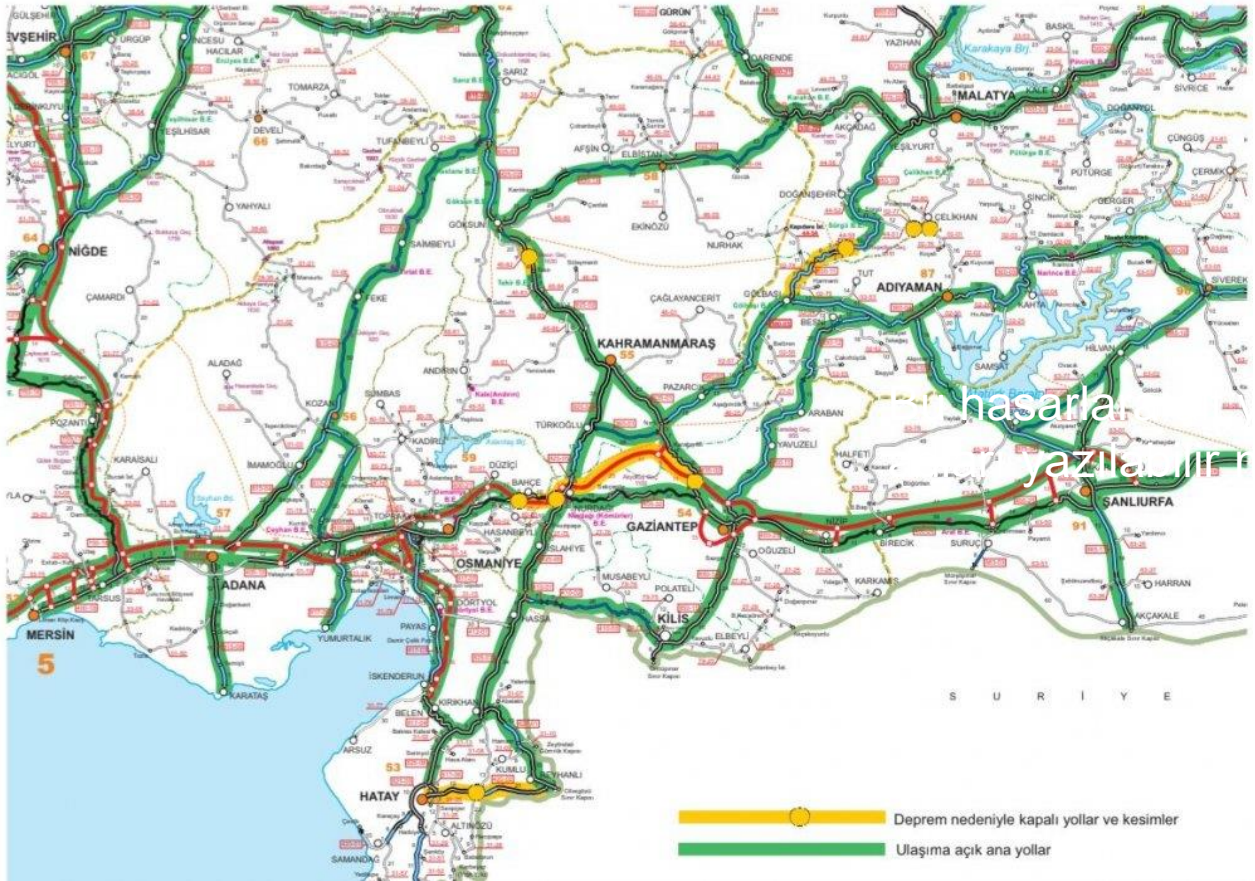
The map of Damaged Roadways from KGM (General Directorate of Highways of Turkey) (yellow lines indicates roadways closed to traffic due to damage)

Damage occurred due to

- 1) Separation or collision of bridge deck with abutments
- 2) Faulting induced deformations
- 3) Retaining wall failures
- 4) Deformation of pavement (separation or buckling=)
- 5) Fall of bridge decks
- 6) Tunnel damage
- 7) Embankment failures

The above damages occurred along Tarsus-Adana-Gaziantep Highway, Malatya Adıyaman Highway, Kahramanmaraş-Malatya highways.

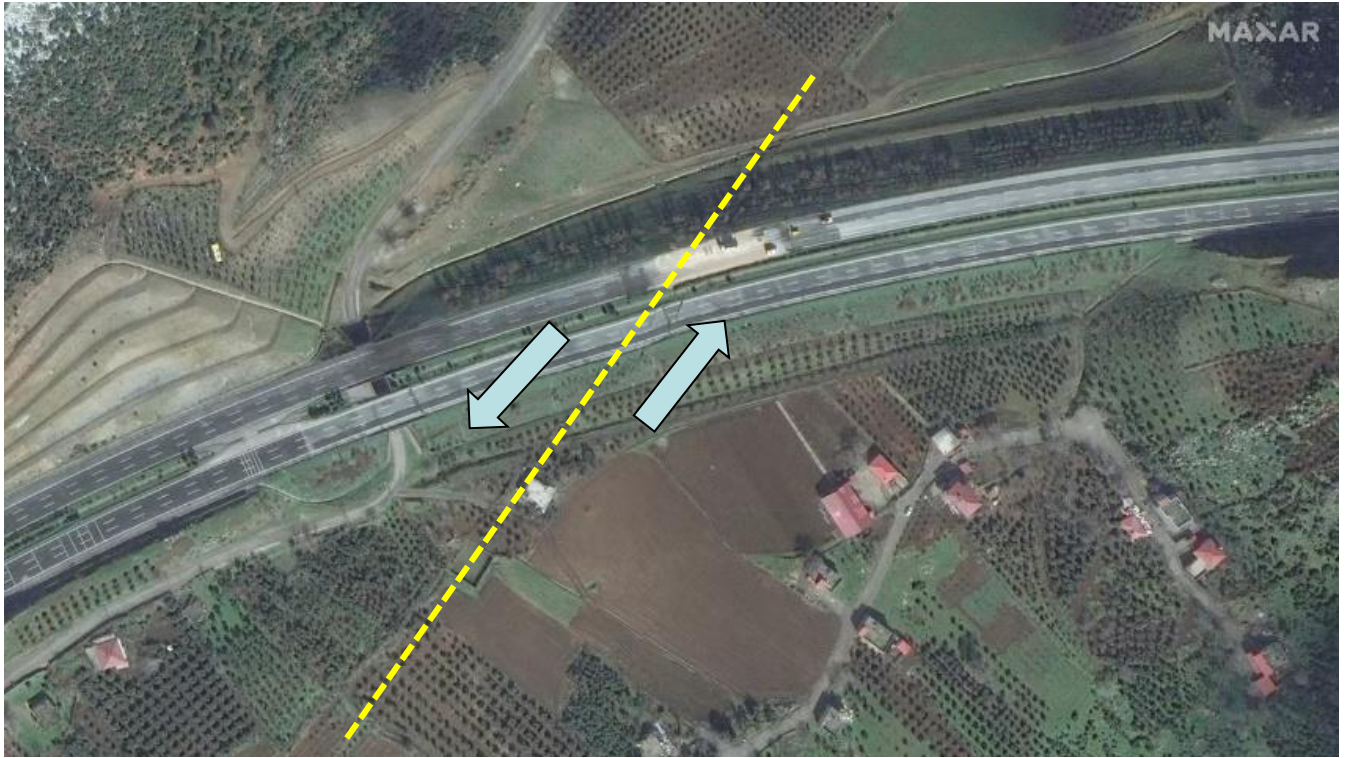
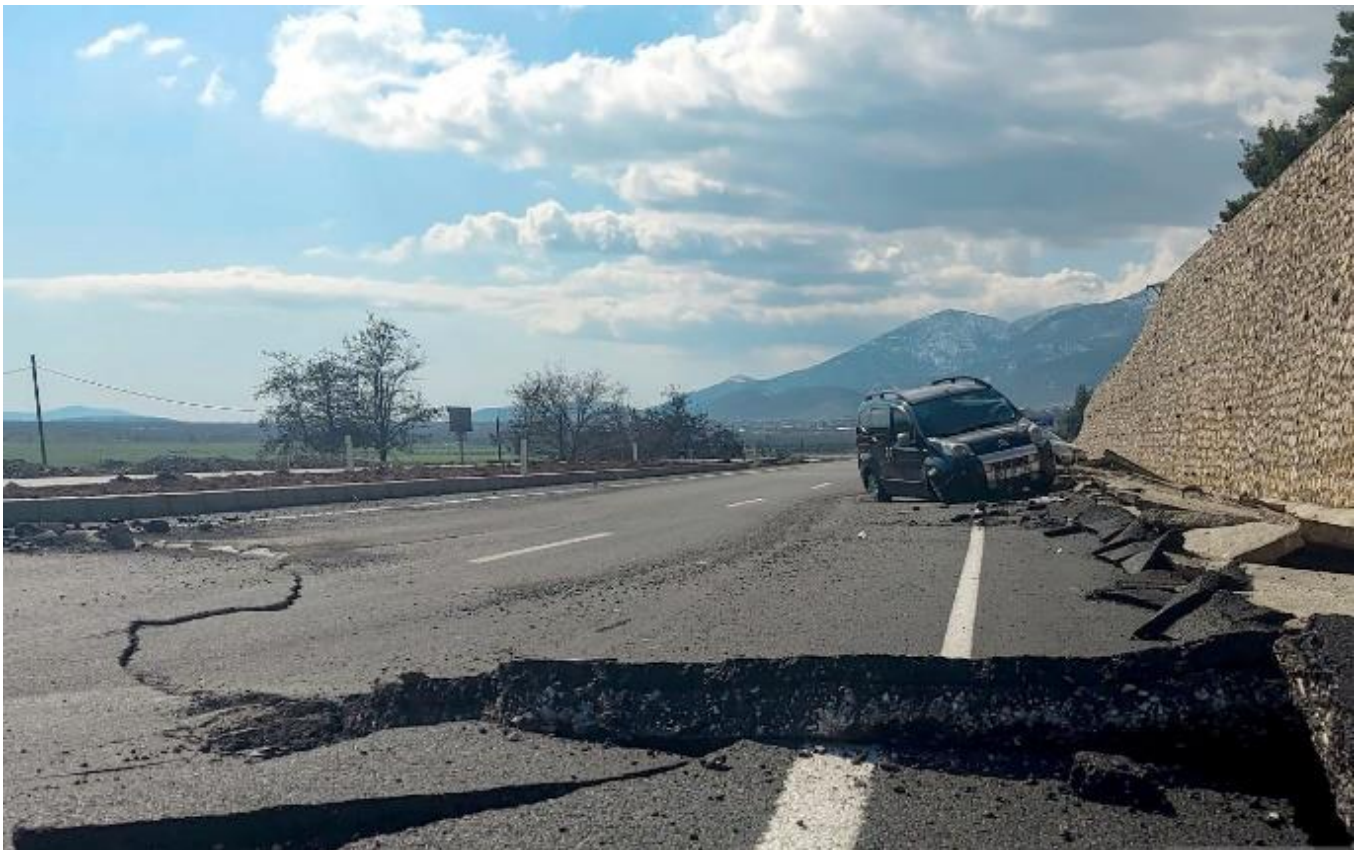
Damage of Tarsus Adana Gaziantep (TAG) near Islahiye by the fault rupture

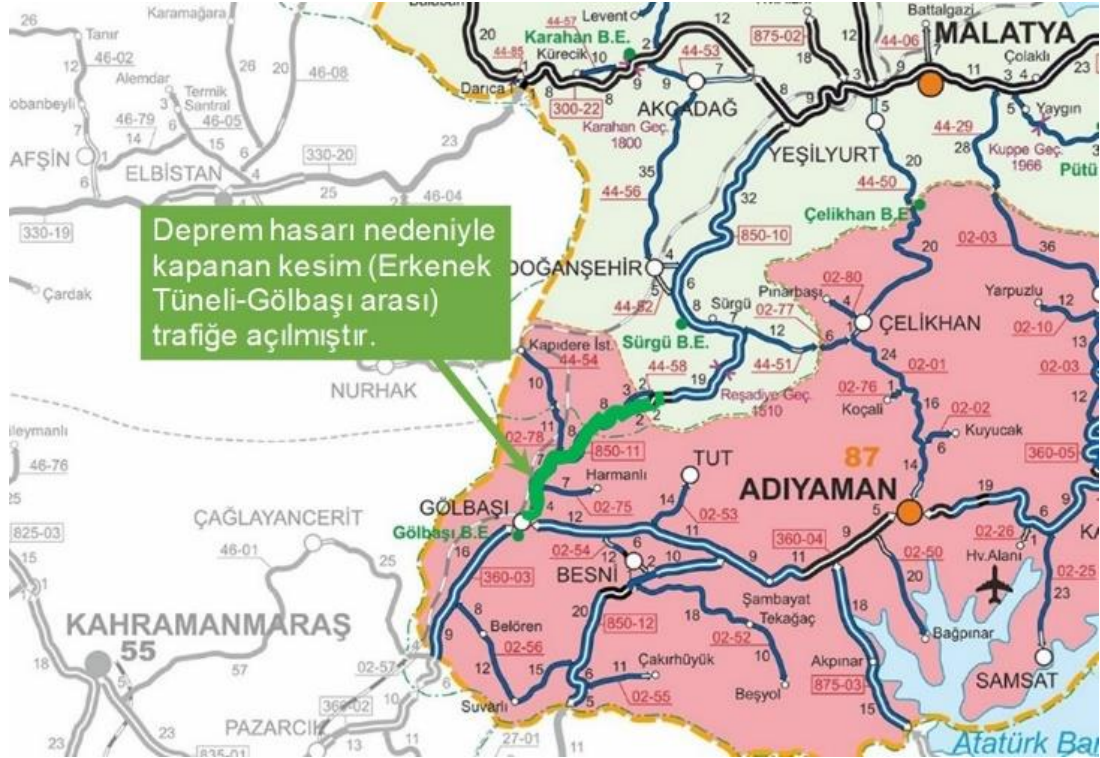
Rockfalls at the portal and spalling of concrete lining of the Erkenek Tunnel occurred as reported by KGM. One of Erkenek Tunnel tubes is closed to traffic while the other is utilised for traffic despite some spalling location of the lining were reported at some locations. The tunnel was almost on the activated Erkenek fault.

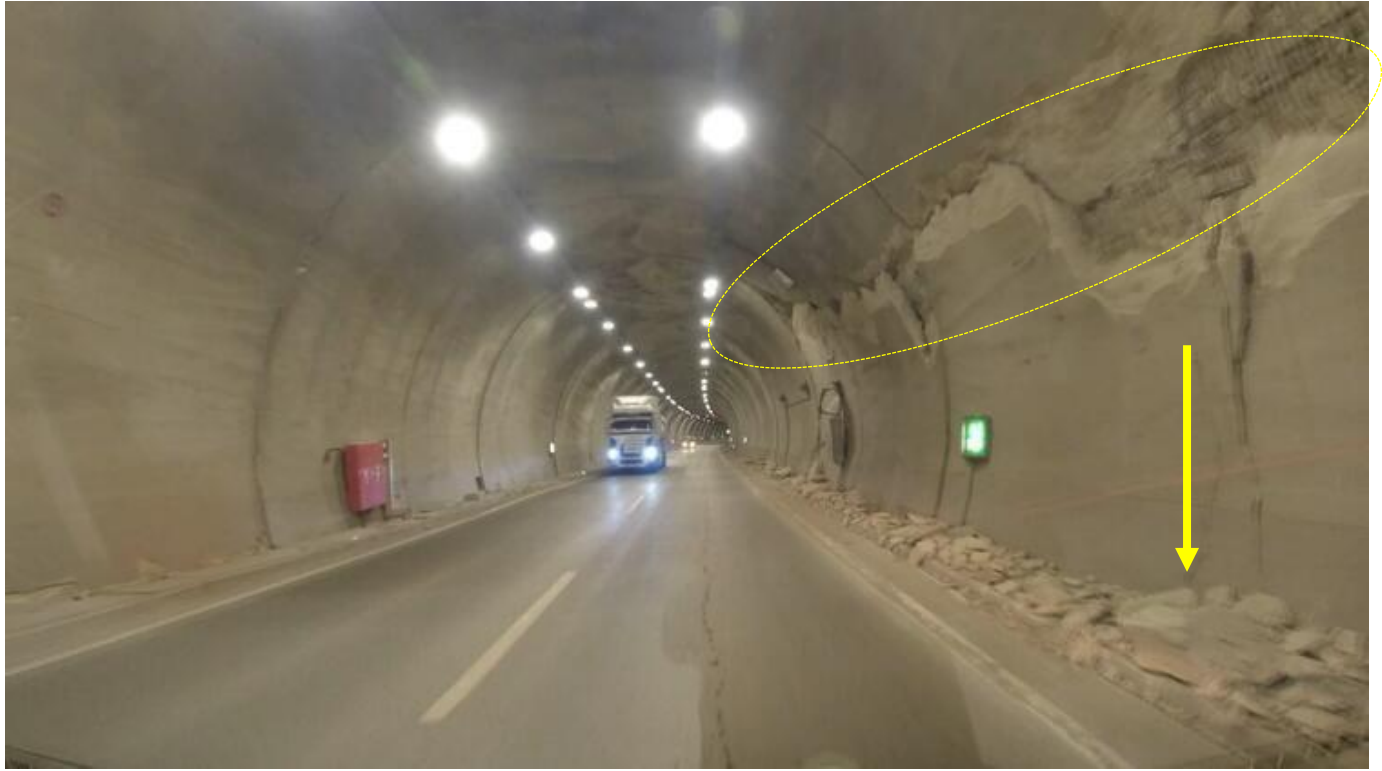
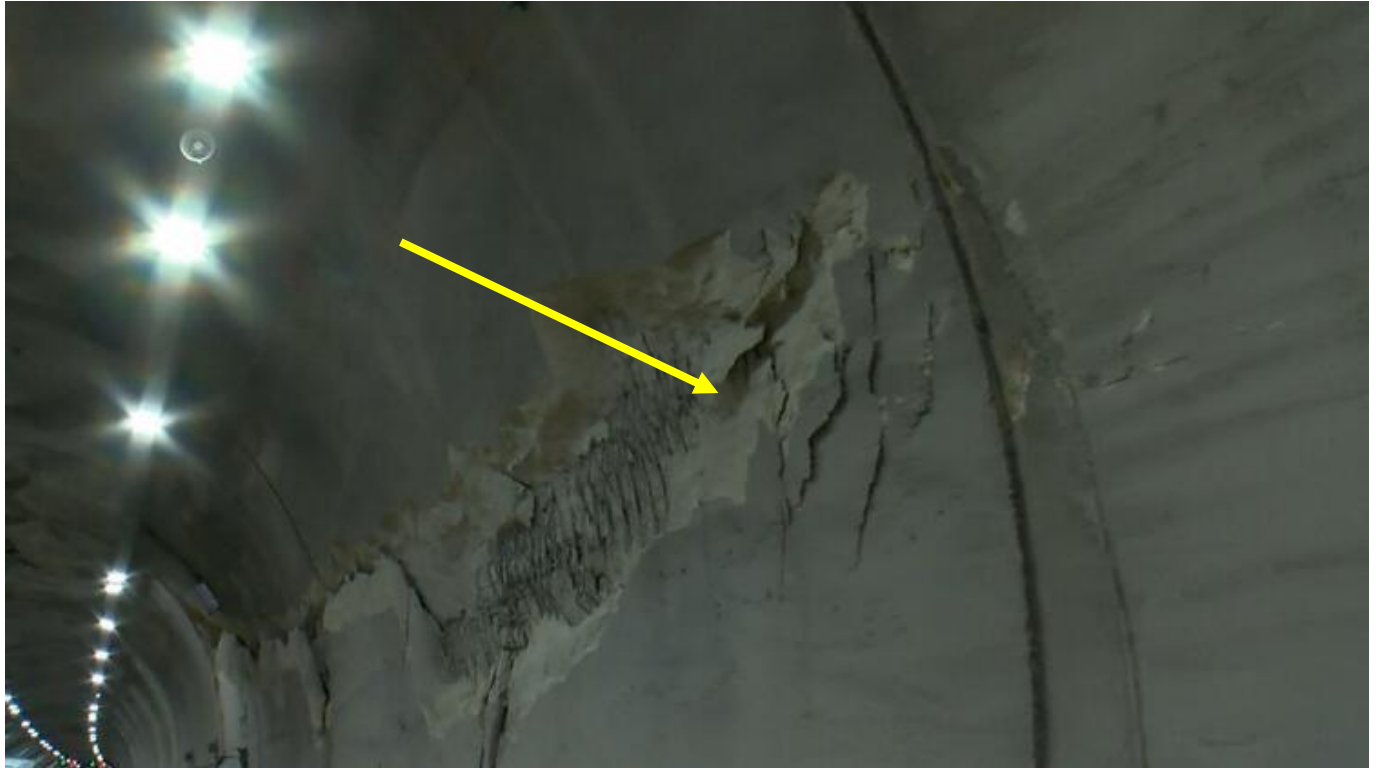
Spalling of concrete linings in Erkenek Tunnel

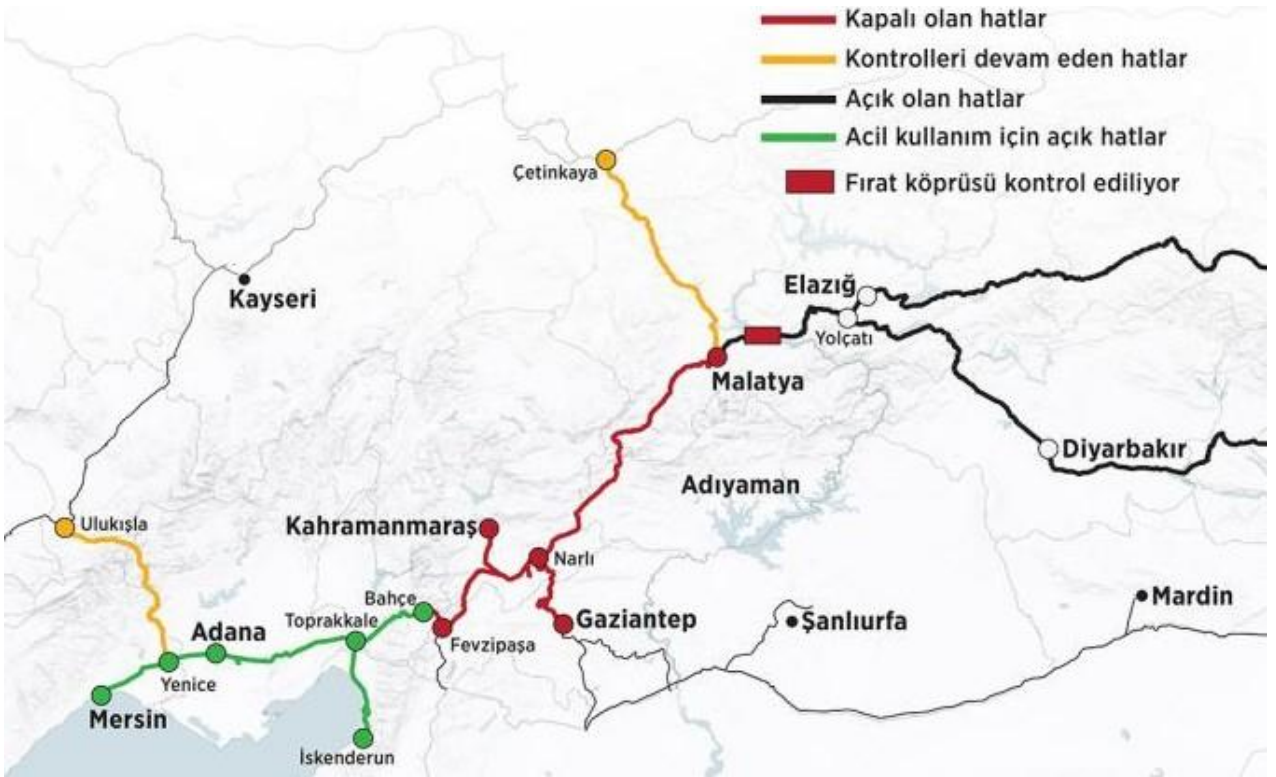
Locations of the damaged railway lines (from TCDD)

Damage was mainly caused by deformation of rails wherever earthquake faults crossed. In addition, trains and wagons were derailed or toppled. Rockfalls and slope failures also caused obstructions.

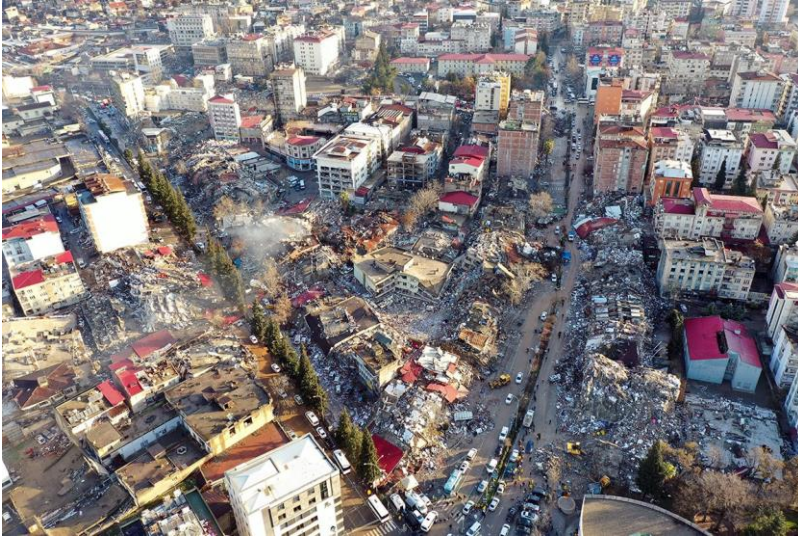
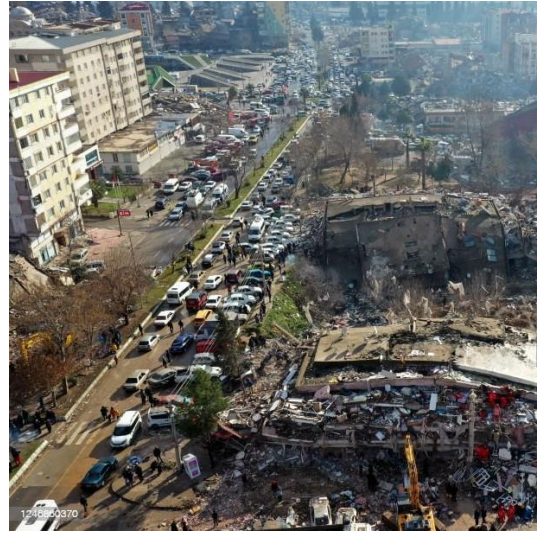
Views of Building Damages
