**A QUICK REPORT
ON
PAZARCIK AND EKİNÖZÜ EARTHQUAKES
(TÜRKİYE) OF FEBRUARY 6, 2023**

Ömer AYDAN* and Reşat ULUSAY**

15 February 2023

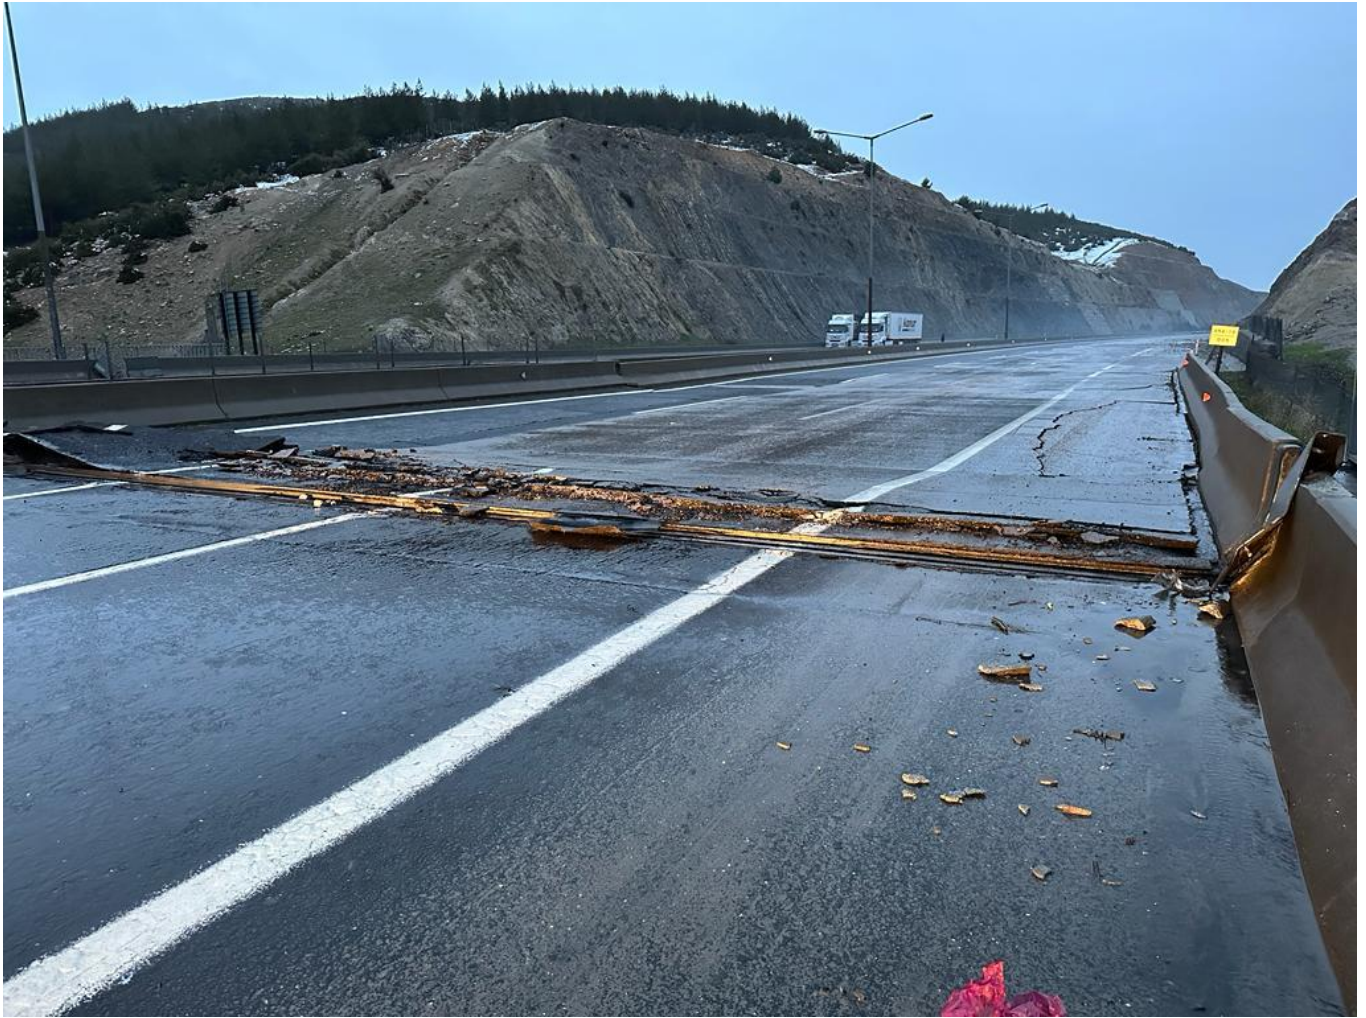
Separation or collision of bridge deck with abutments

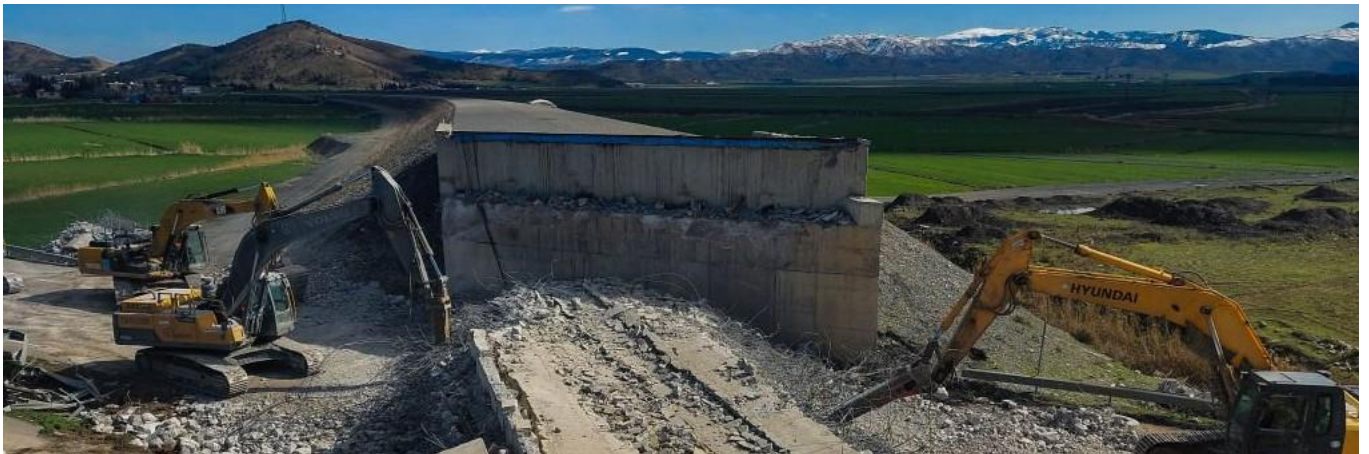
Bridge deck fall

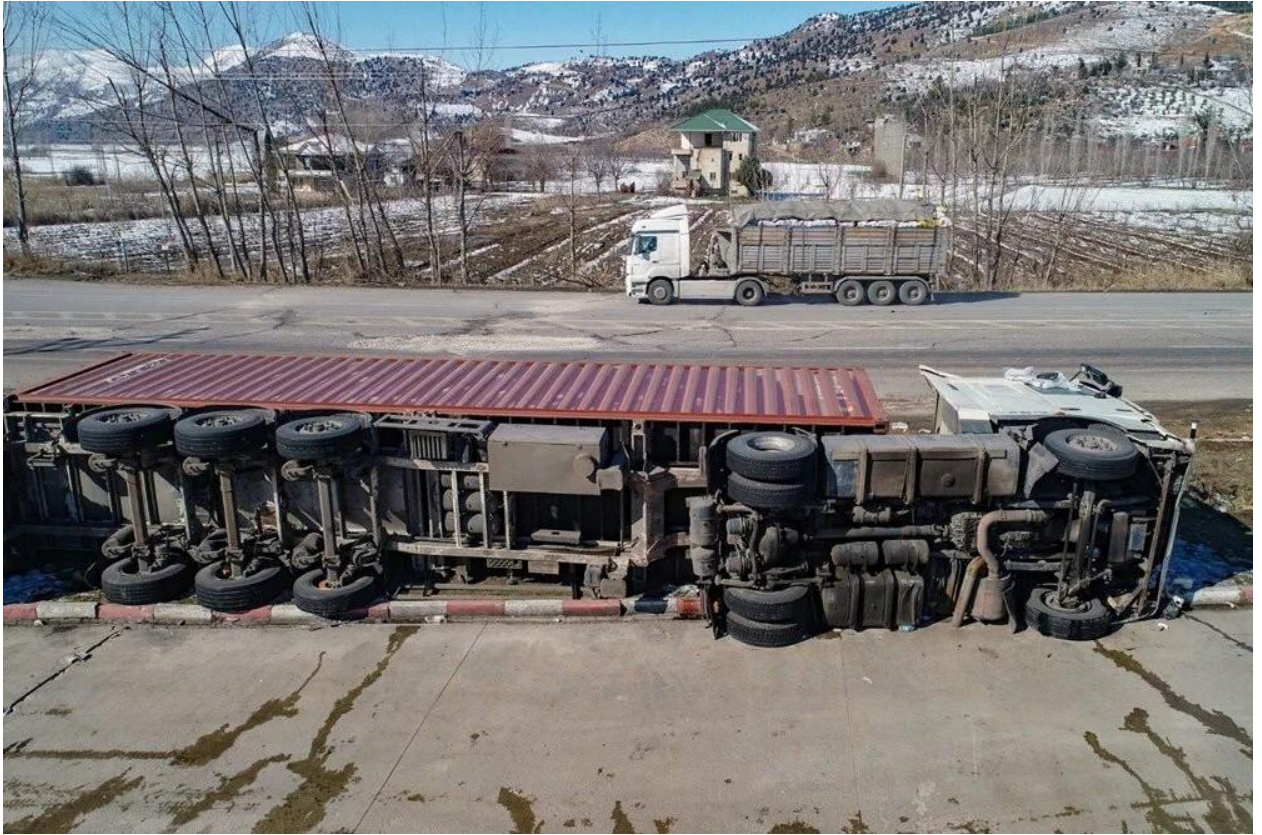
Topped stationary vehicles

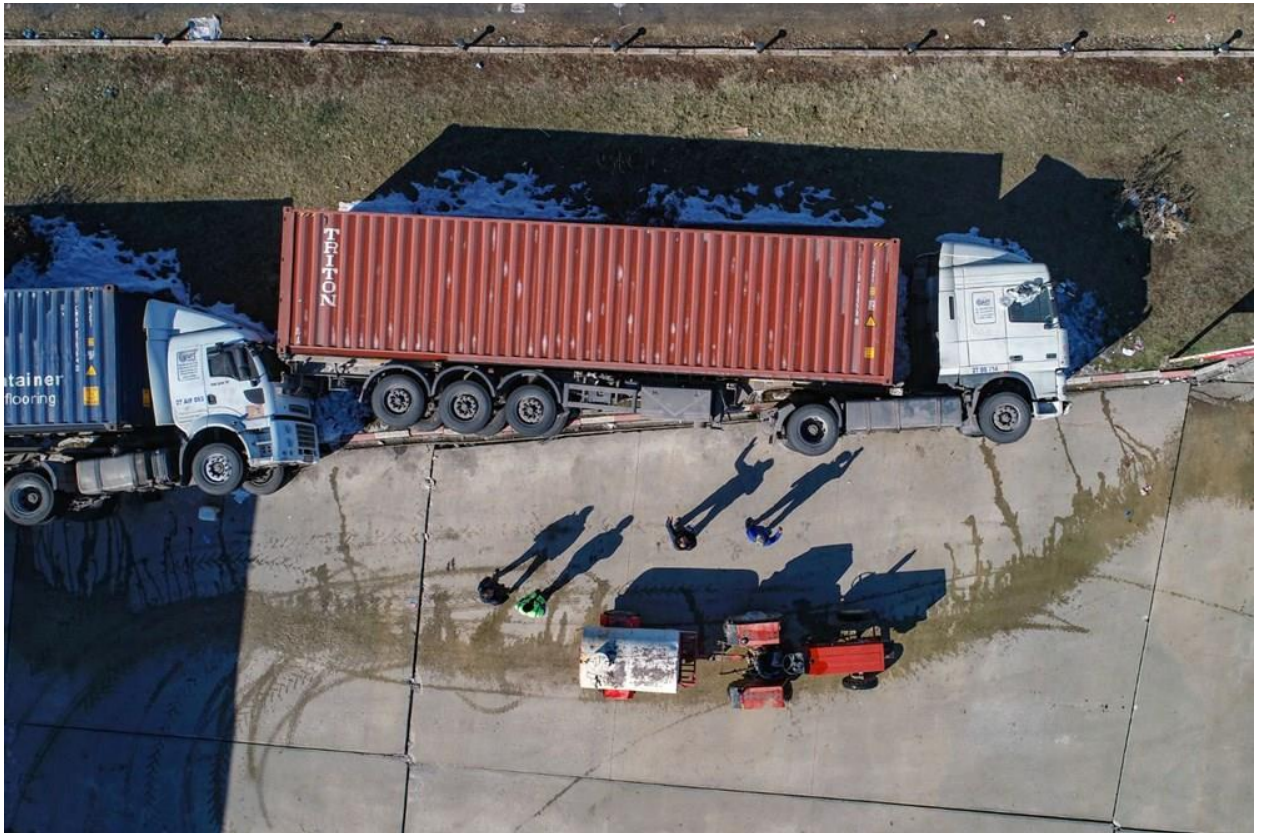
Adiyaman-Malatya highway *(Photos: Internet)*

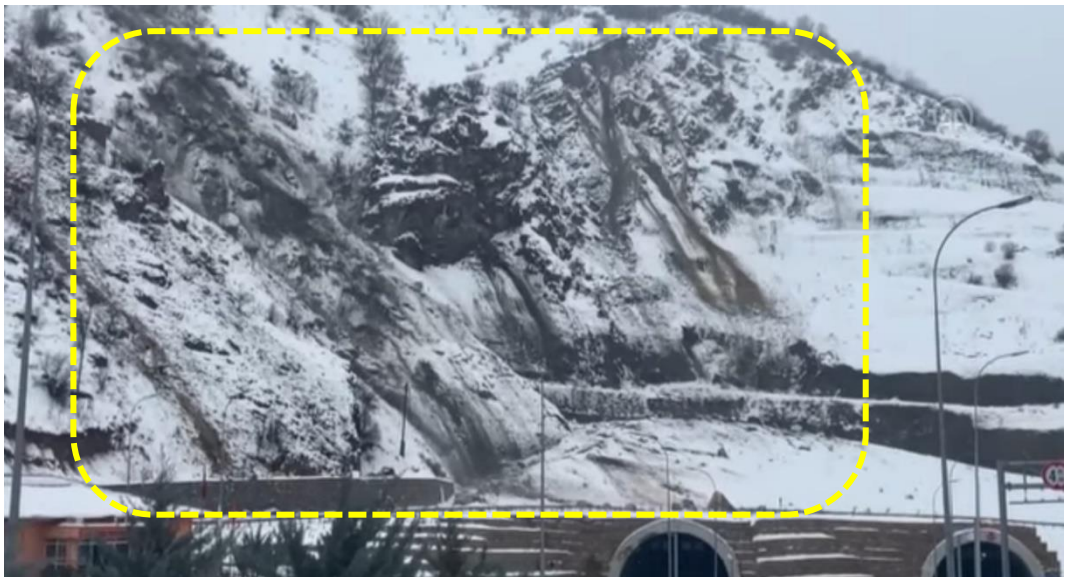
Rockfalls at the portal and spalling of concrete lining of the Erkenek Tunnel occurred as reported by KGM. One of Erkenek Tunnel tubes is closed to traffic while the other is utilised for traffic despite some spalling location of the lining were reported at some locations. The tunnel was almost on the activated Erkenek fault.

Traces and Rockfalls above the portals of Erkenek tunnel

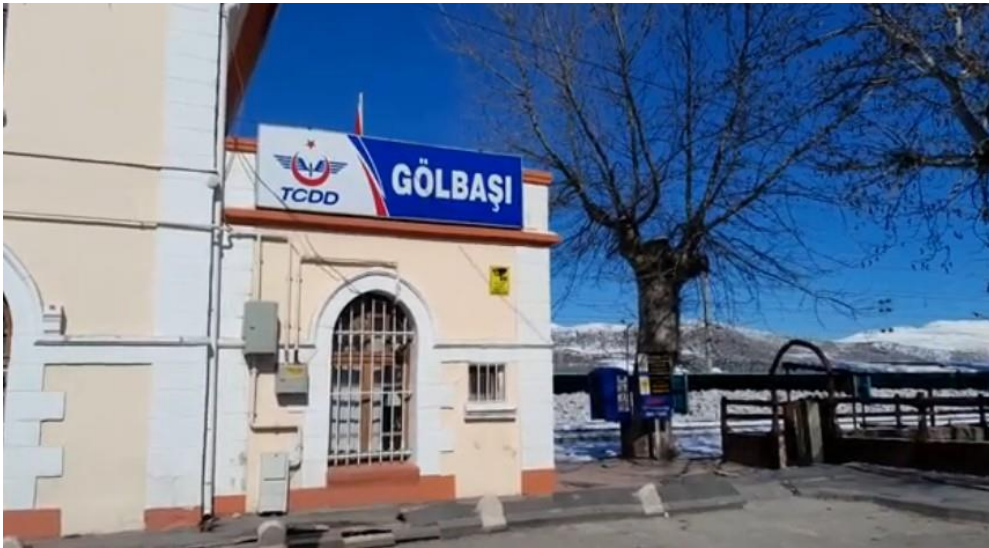
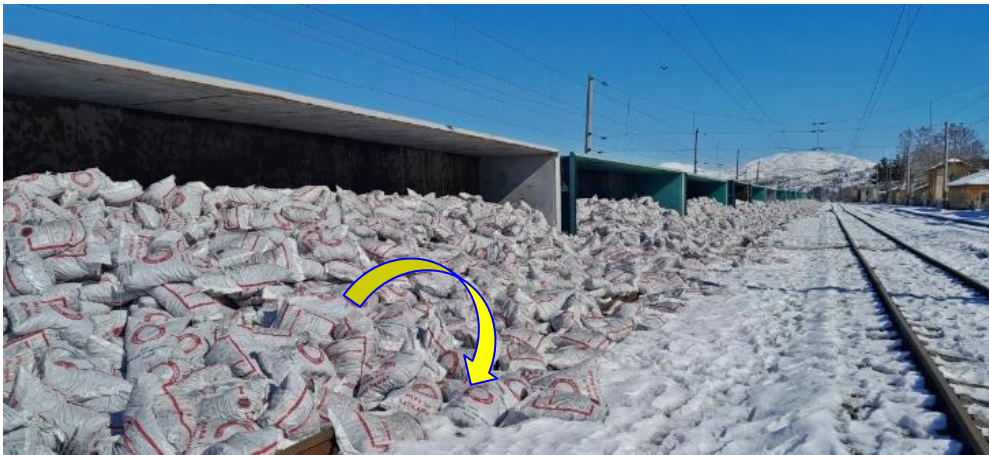
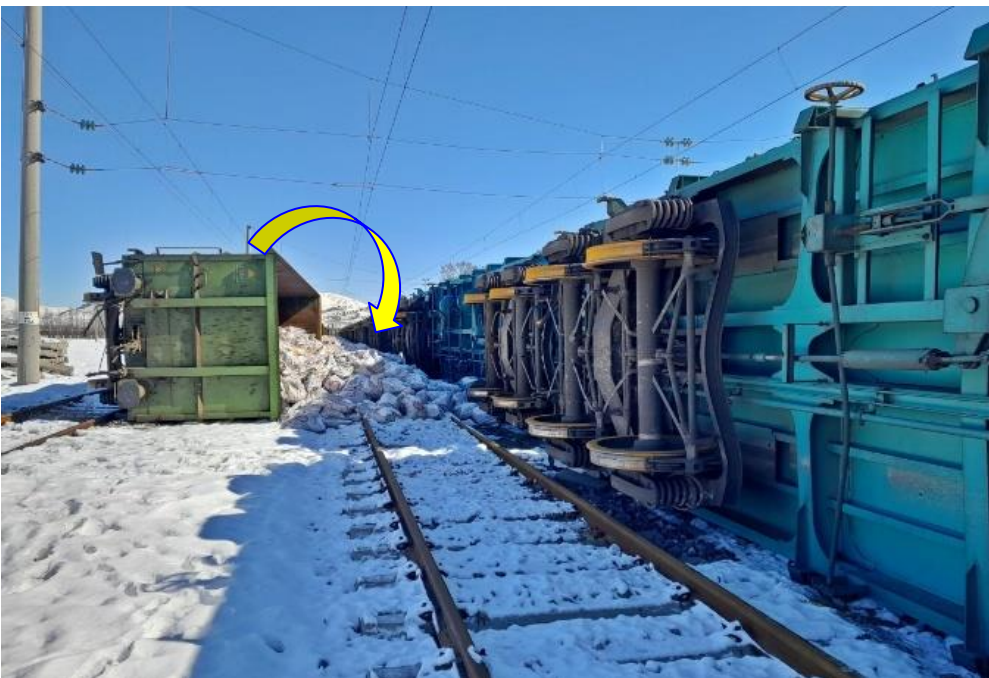
Damage was mainly caused by deformation of rails wherever earthquake faults crossed. In addition, trains and wagons were derailed or toppled. Rockfalls and slope failures also caused obstructions.

Deformed rails in Gölbaşı

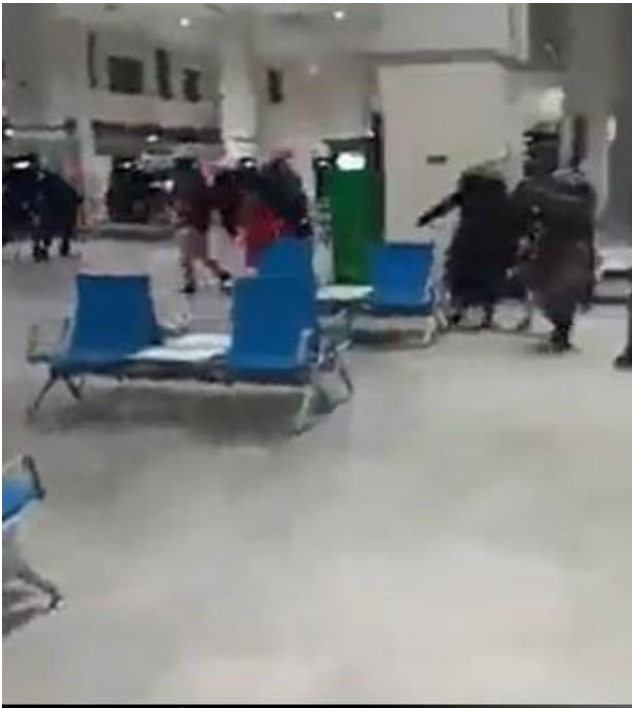
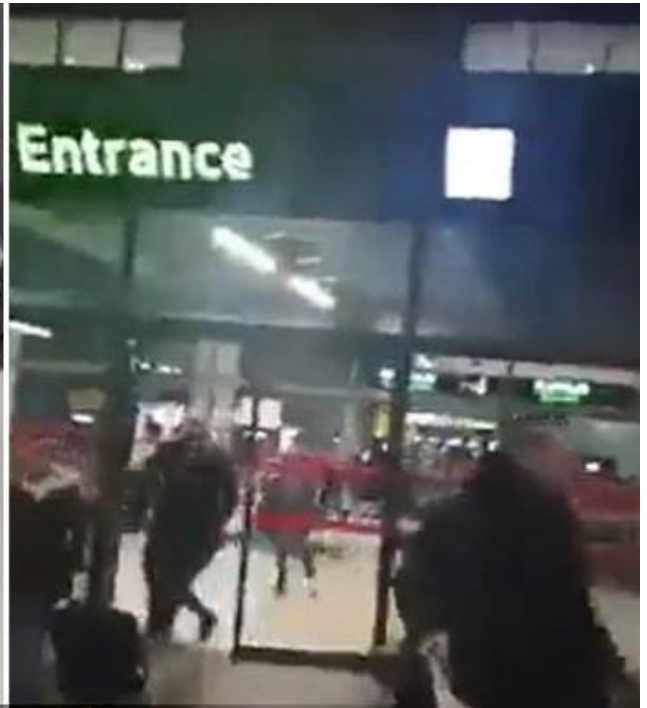
Gaziantep Airport at the time of Pazarcık earthquake occurred. Note the small pieces of debris falling from the suspended ceilings. Similar situation occurred at Malatya Airport.

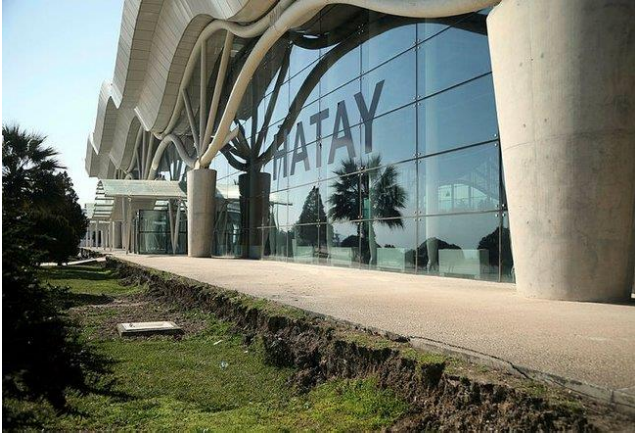
Ground settled around the terminal building at Hatay Airport

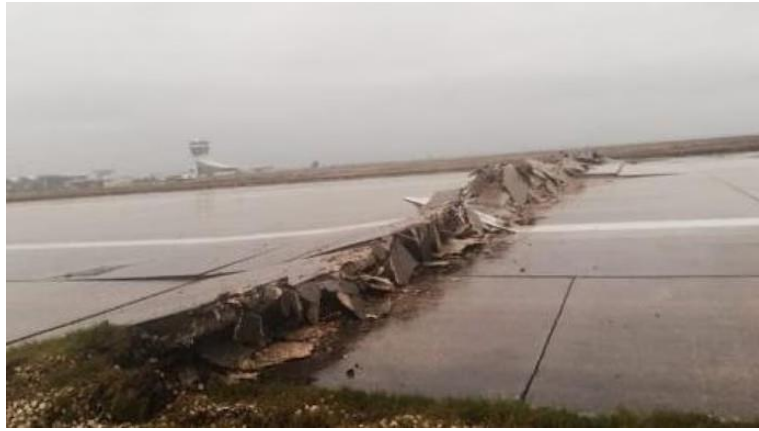
Runway buckled at Hatay Airport

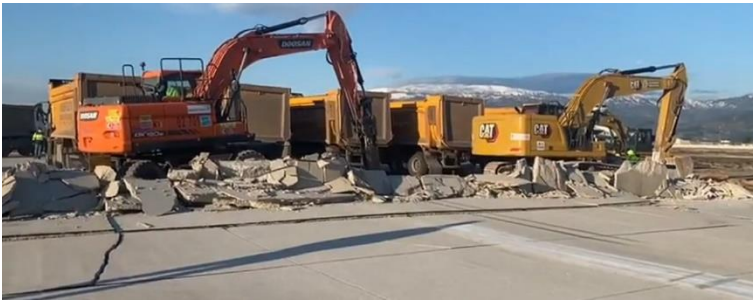
Under reparation

Runway was repaired on February 11, 2023

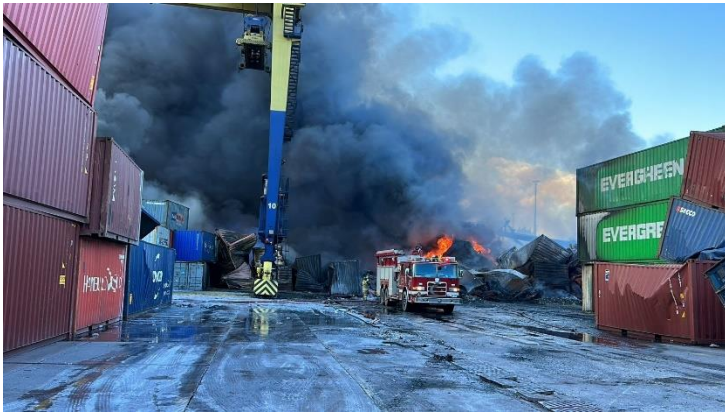
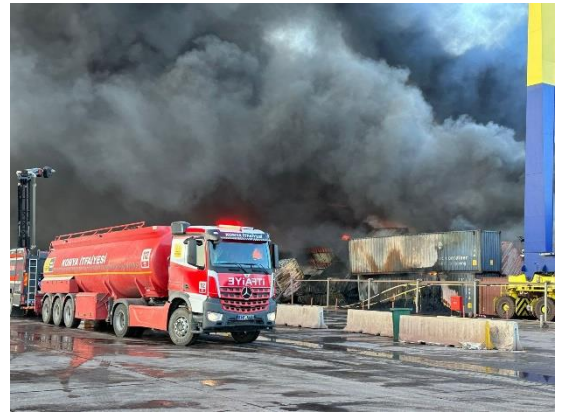
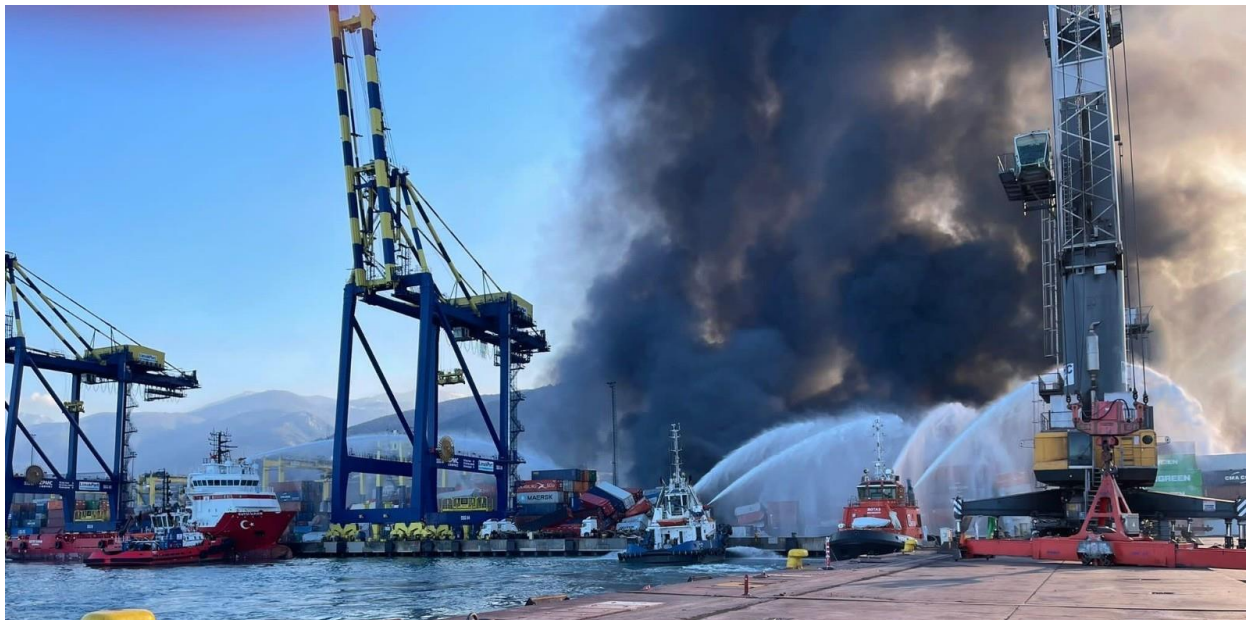
Fire at Iskenderun Port

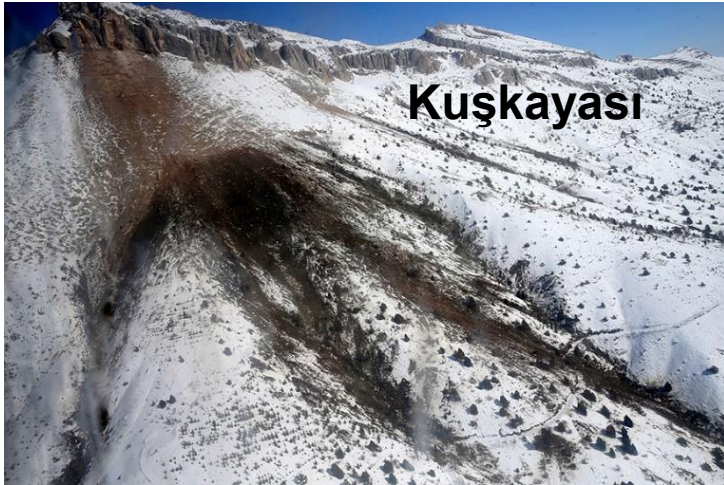
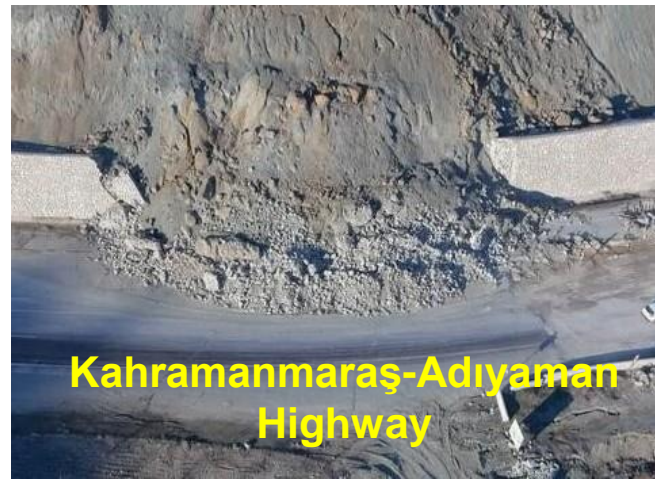
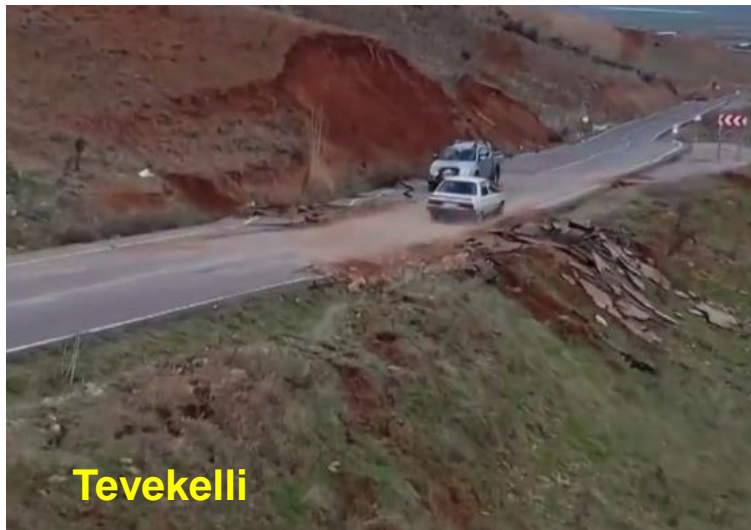
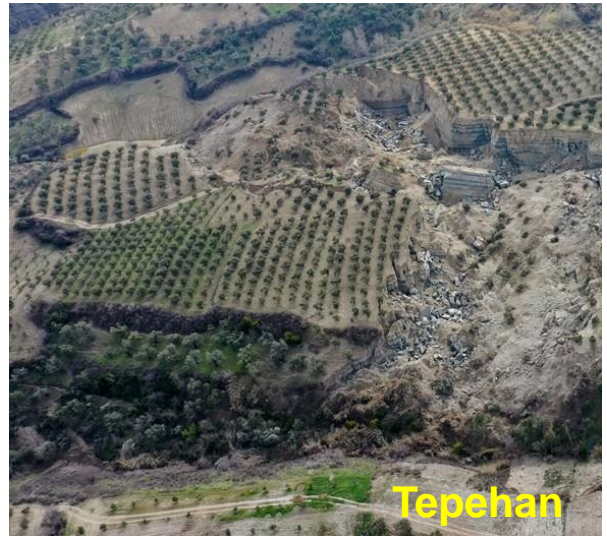
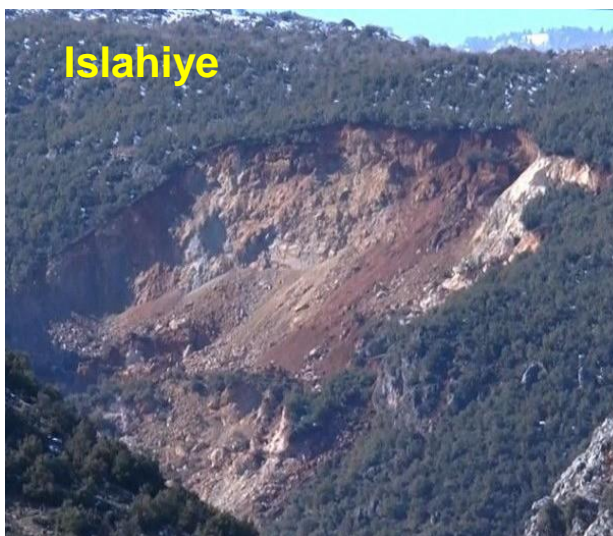
Slope Failures (Landslides)

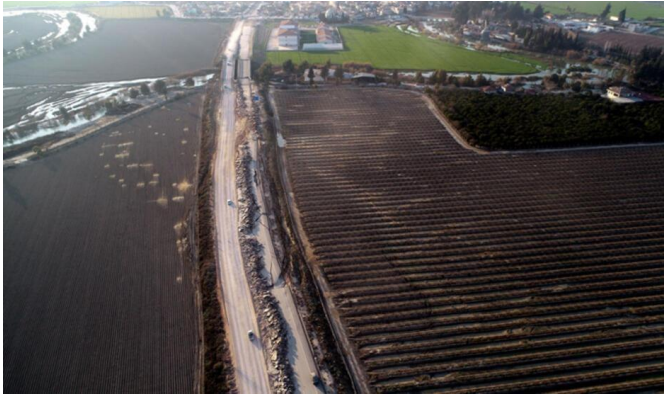
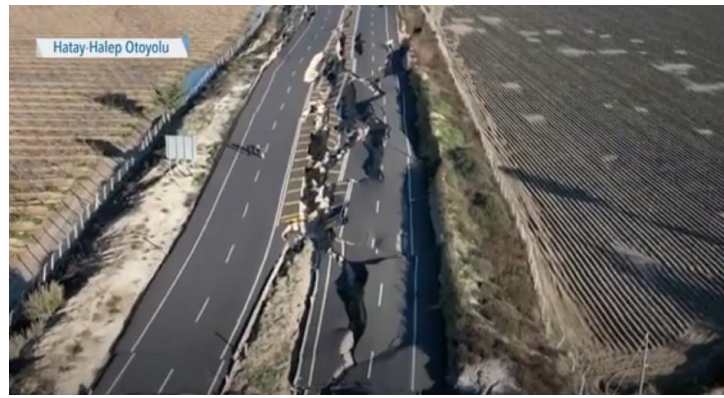
Antakya-Reyhanlı Highway

Liquefaction and Lateral Spreading

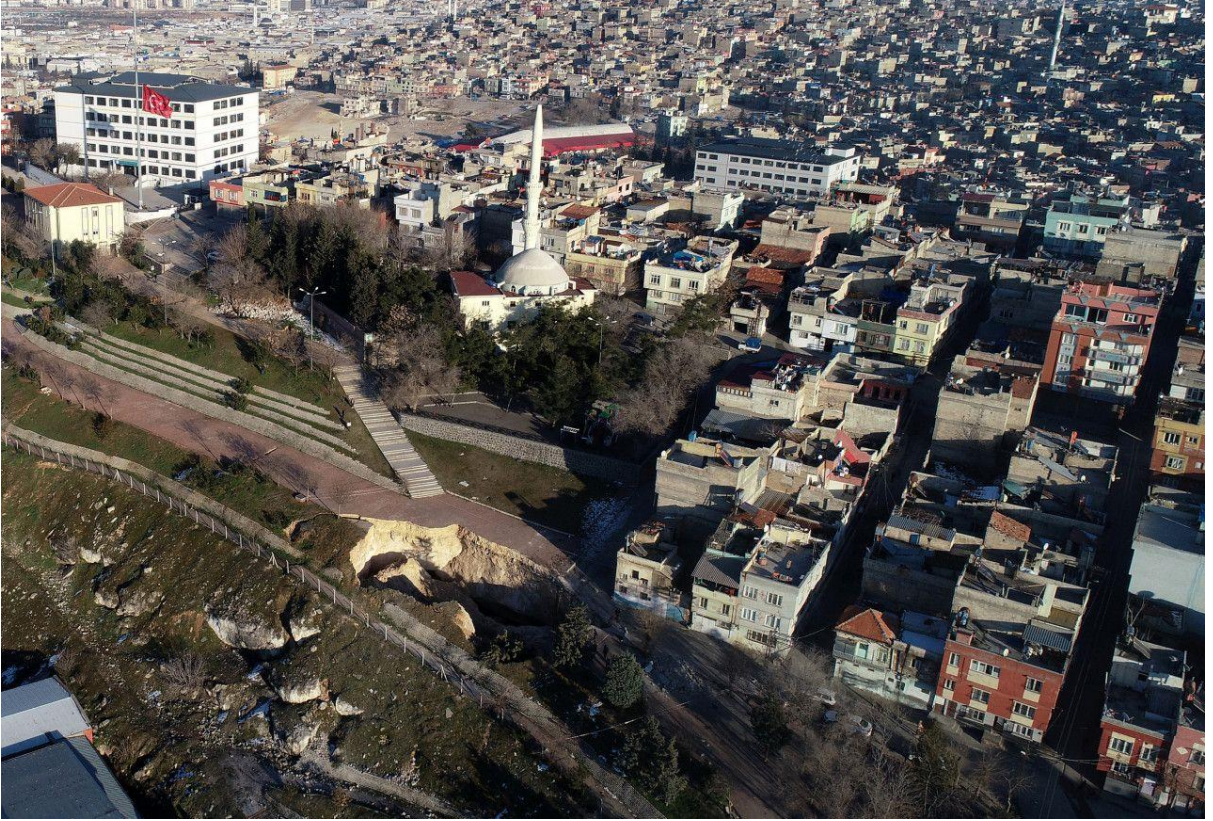
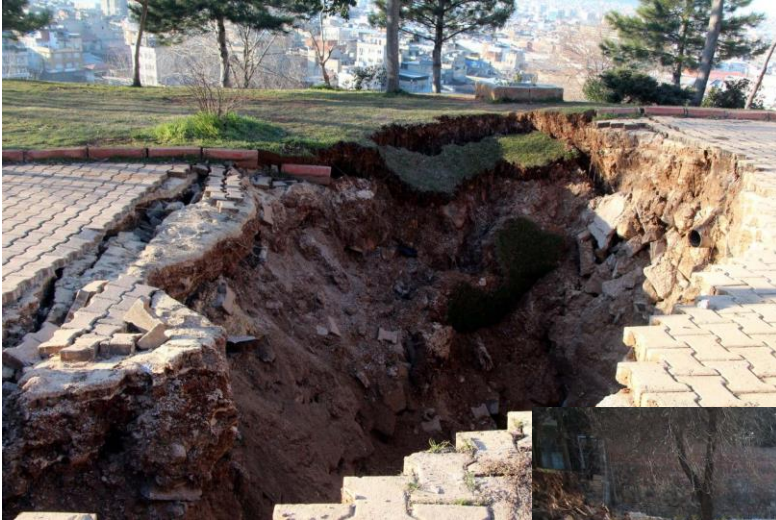
Gaziantep Yavuzlar
District

Sinkholes

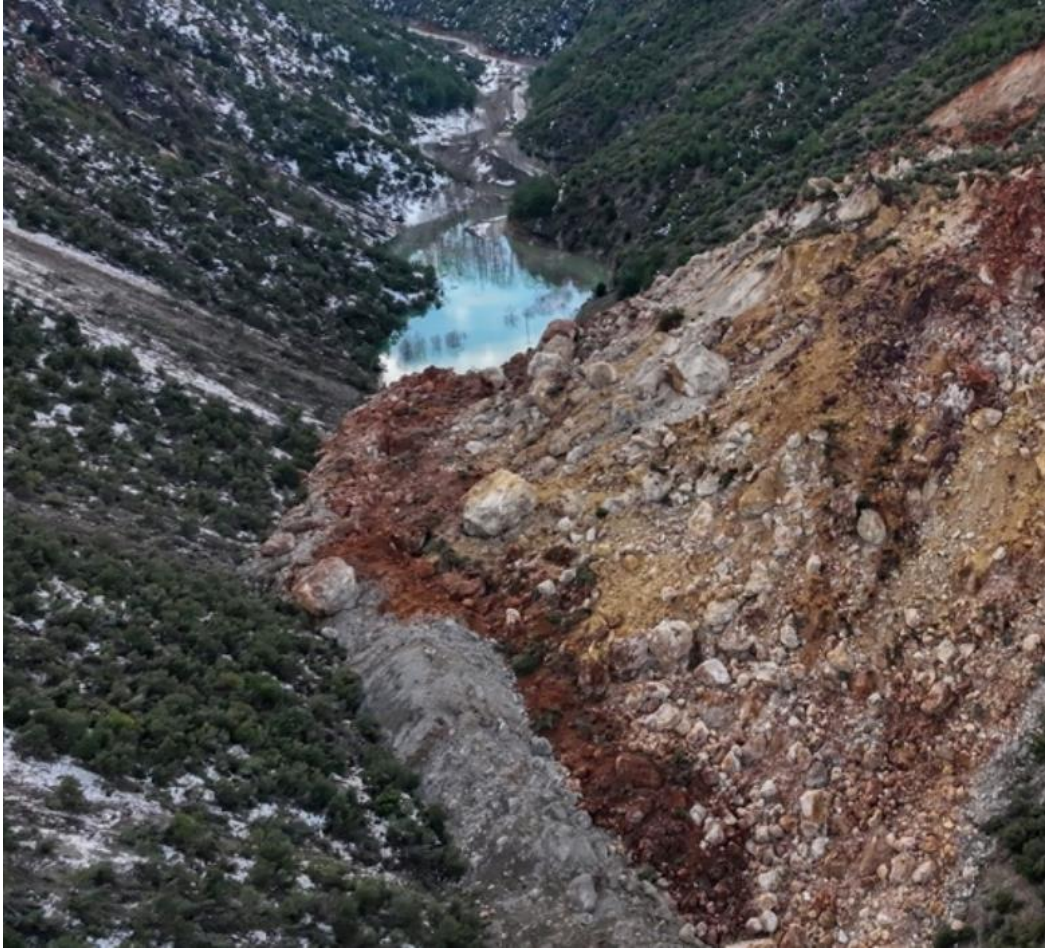
Islahiye

Landslide Dams

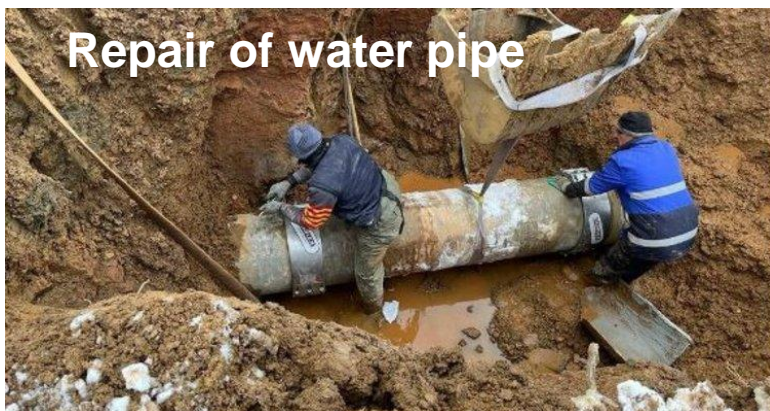
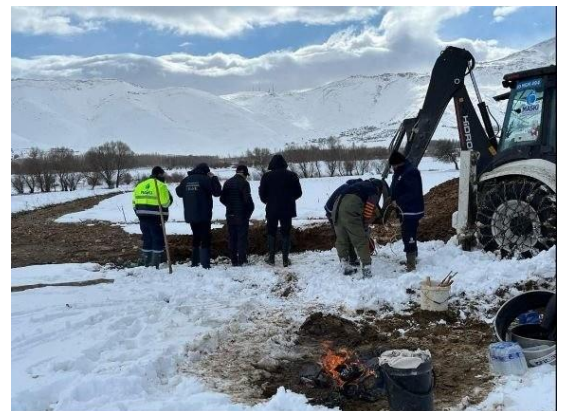
LIFELINES

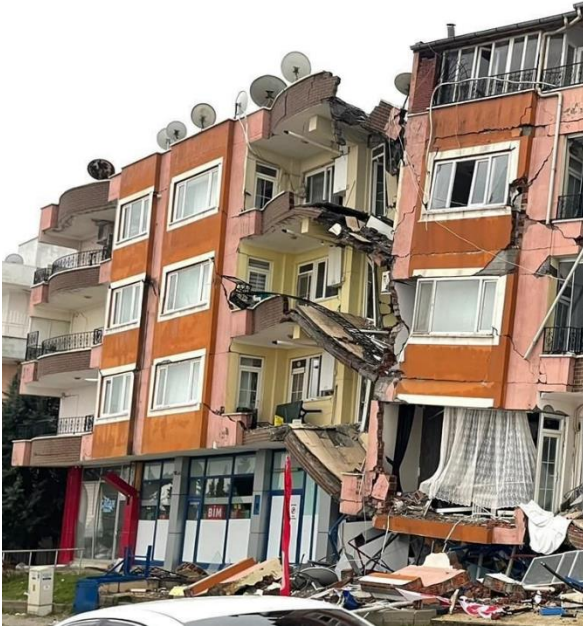
Adiyaman

Poor workmanship: There are two kinds of poor workmanship. One of them is that the connections of columns and beams were very weak since the connections of steel bars were not properly done. The second one is that the granulometry of the sand and gravel of concrete was very poor and the range was wide. In addition, big chunks of gravel blocked the concrete during casting at locations where steel connections were dense and this resulted in very porous and weak connections. During shaking, it seems that concrete at the connections first failed and this subsequently caused the buckling of steel bars at such locations and rupturing in-fill hollow brick walls in a brittle sense. As a result, the collapse of buildings ended up in a pancake mode.

Soft Story: Many buildings had shops at their ground floor. As there are generally no shear-walls to take up the load during earthquakes, the total load is transferred onto the columns. The super structure acts as a top-heavy structure on the columns and in-fill walls, which are in poor contact with columns and beams, has no effect against the earthquake loading and they fail subsequently.

Pounding of adjacent structures: Buildings at the corners of streets were mostly collapsed as a result of pounding with the adjacent building.

Buildings with problematic issues mentioned above

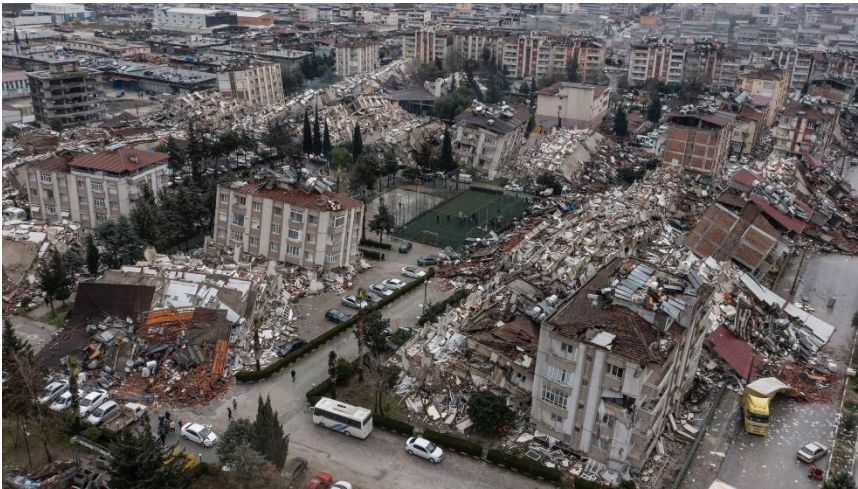
Antakya (Hatay)

Views of Building Damages

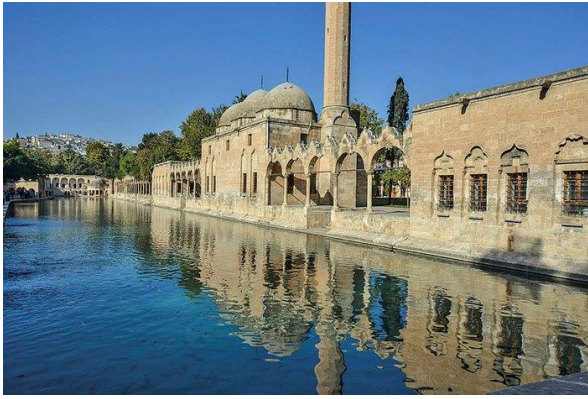
Before the earthquake transparent
Balıklıgöl, Şanlı Urfa

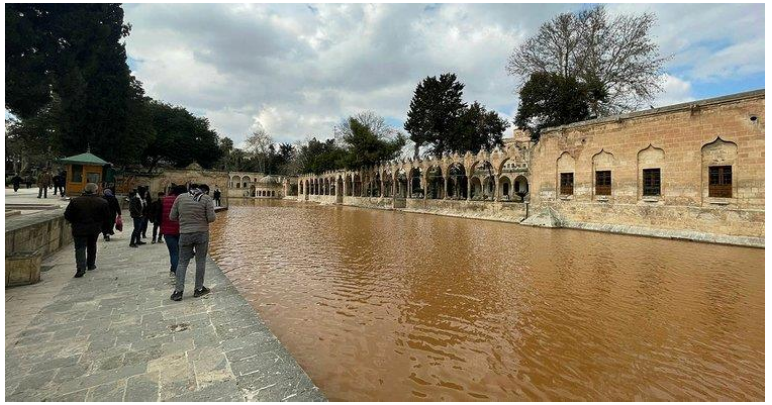
After the earthquake muddy Balıklıgöl,
Şanlı Urfa

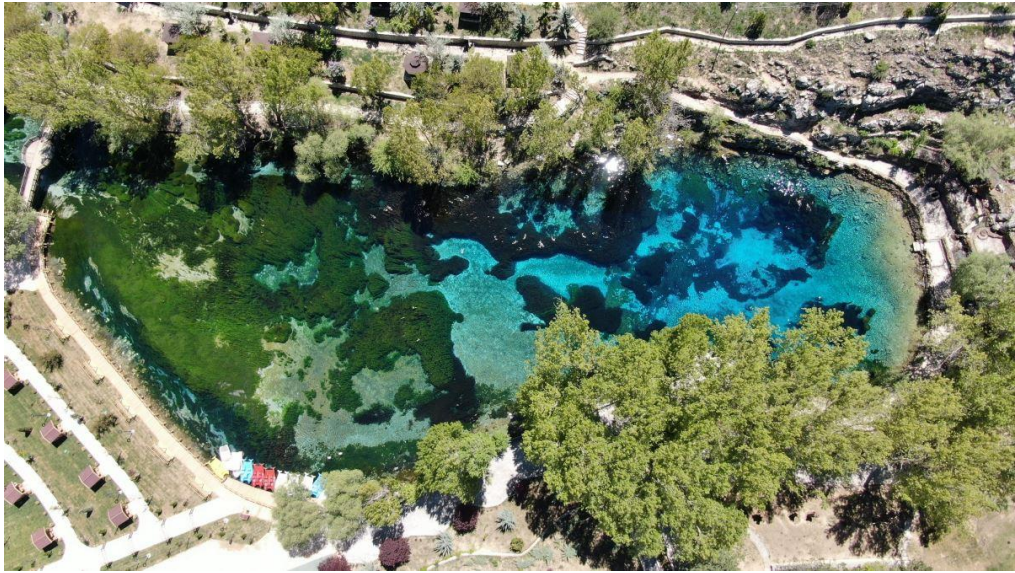
Before the earthquake transparent Gökpınar Lake, Gürün, Sivas (124 km
from M7.8 epicenter)

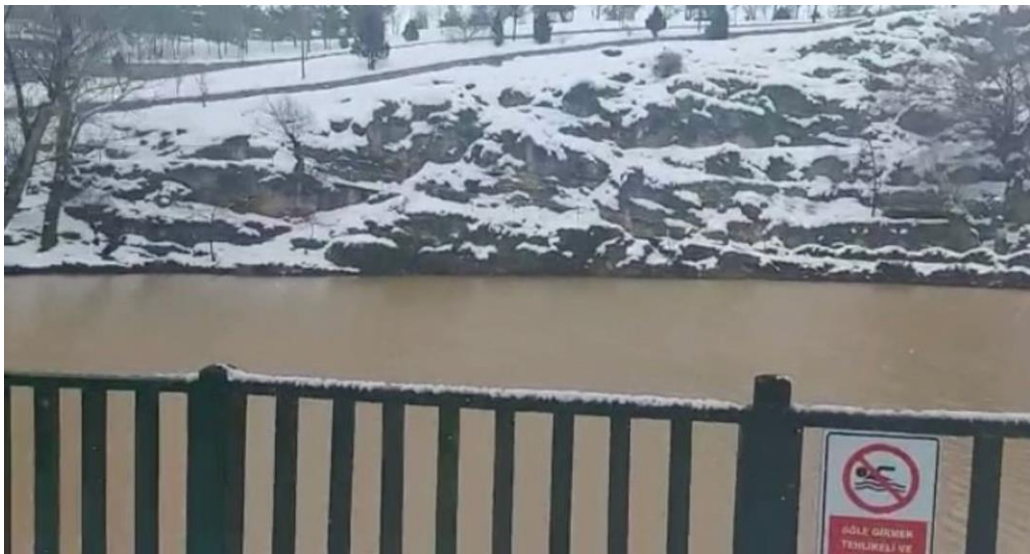
After the earthquake muddy Gökpınar Lake, Gürün, Sivas
